BladeCheck™ – Measurement of the Blade Contact-pressure Profile

Small thing – huge impact

Presented at the 20th International Munich Paper Symposium IMPS 2011

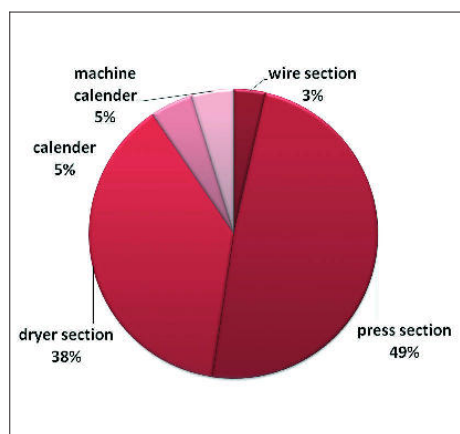
Fig. 1: Distribution across the location in the paper machine

Fig. 1 shows the distribution of the measurements made in relation to the location of the measured blade. One can clearly recognise that nearly half of the measurements took place in the press section, and almost another 40 % in the dryer section. The remainder is distributed fairly evenly between the calender, the calender stack and the wire section.

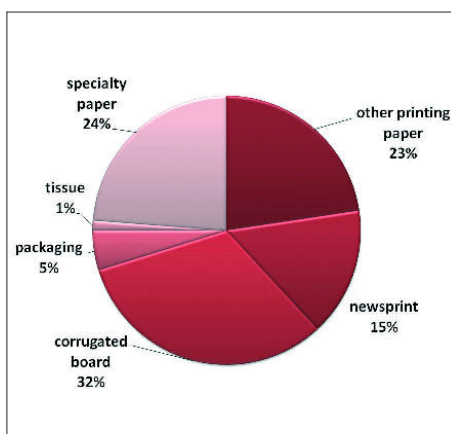
Fig. 2: Distribution of product groups

The distribution of the measured blade across a variety of papers is shown in Fig. 2. Approximately one third accounts for corrugating medium and test-liner, 23–24 % for specialty papers and printing papers, 15 % for newsprint paper, 5 % for packaging paper, and 1 % for tissue. Since the optimal function of the creping blade is of major importance for tissue production, this small percentage is surprising. Apart from that, nothing unusual is evident in Fig. 2.

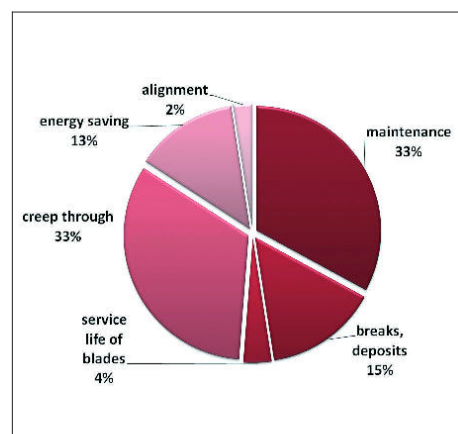
Fig. 3: Reasons for BladeCheck™ measurements

Looking at the problems shown by the measurements, in Fig. 3 it is quite clear that “winder” or “passing” problems as well as issues of maintenance dominate the statistics with two-thirds of all problems. This is followed by issues related to breaks, deposits and energy savings. Only 4 % of the problems are due to blade life-time and parallelism.

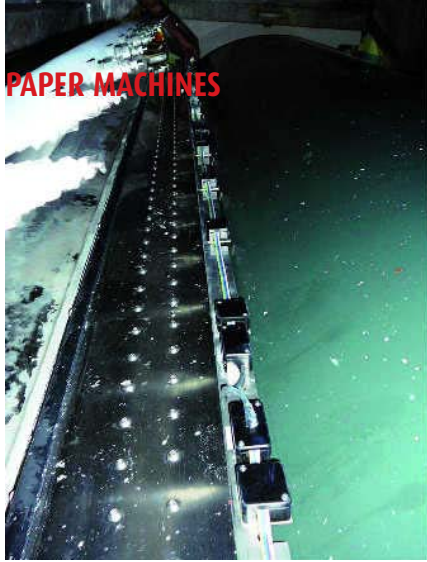
Fig. 4: View of a BladeCheck™ measuring device in action

In Fig. 4, an installed BladeCheck™ measuring device, ready for data recording, can be seen. The little black boxes of the strain gauges with associated electronics and cabling are also visible. The roll to be measured is shown on the right side, in blue-green colour

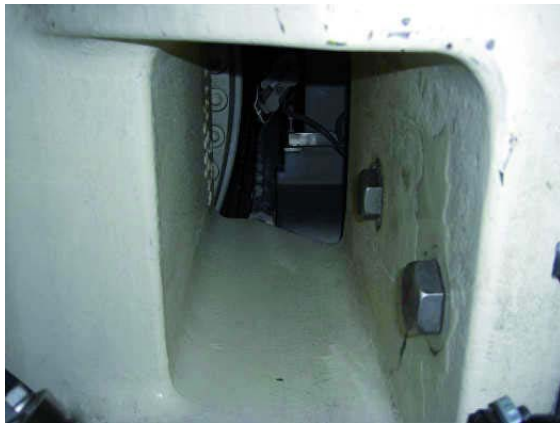
Fig. 5: View of a "hidden" blade in a press section

Unfortunately, the installation locations of the blades in modern paper machines are almost impossible to reach in some positions. Fig. 5 shows the beginning of a blade through the framing. It is pulled through this narrow opening for replacement. This is reminiscent of some modern cars which need the mudguards and the bumper dismantled simply to change the bulb of the parking light. At that point, one would gladly hand over the task to the respective designers and planners.

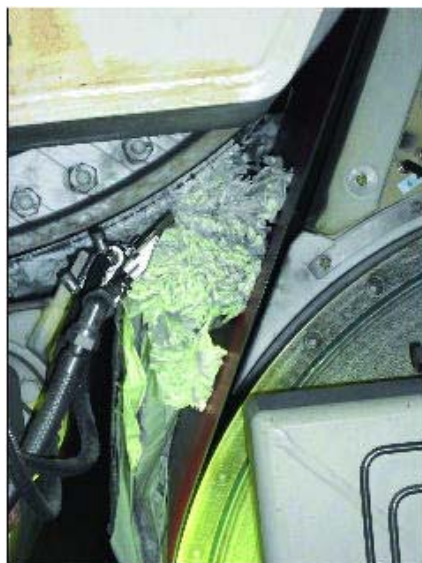
Fig. 6: Blade with a typical "winder" and/or "packer"

As most people have probably never seen a typical "winder" or "packer" on a blade, an example of this can be seen in Fig. 6 below. In such situations, the paper build-up can be very fast, very hard, very thick, and bend under the blade. In the worst case, it can bend not only the blade holder, but also cause tremendous damage to the framing and clothing. We have even been called in on emergency situations where large paper machines had not been running for several days and severe damage had occurred.

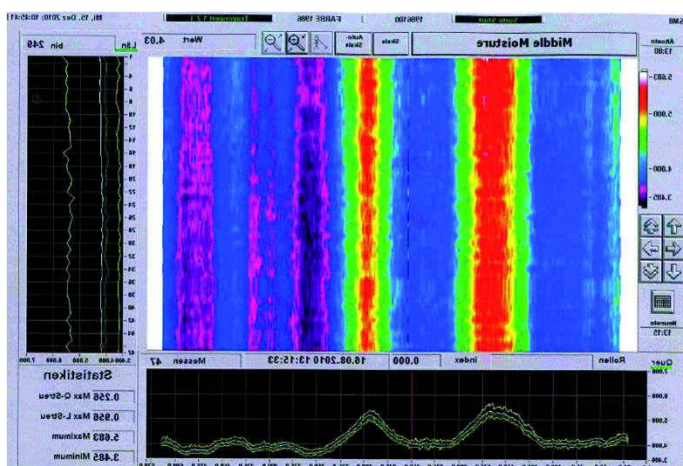
Fig. 7: Poor moisture cross-direction profile

Quite often little attention is paid to the impact of non-optimally working blades on energy consumption and the moisture profile. An example of a poor moisture cross-direction profile is shown in Fig. 7. Here, different colours mean different humidity levels at these locations. One can easily see the differences that occur in the form of narrow and sharp lines. Such moisture fluctuations may well result from defective blades or blade holders, because various contact pressures can lead to different thicknesses of the build-up of deposits on dryer cylinders. The thickness of the deposits directly affects the heat transfer at this point between the cylinder and the paper. This, results in a poorer drying performance, and in moisture fluctuations. In such cases, more energy is saved by measuring the blades in question than by balancing the moisture cross-direction profile by specific remoistening. In this case, expensive equipment is used to compensate a problem in a rather simple part of the machine.

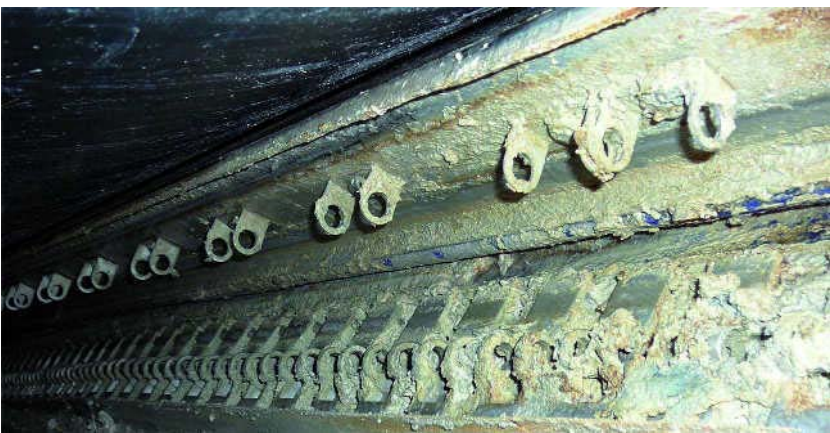
Fig. 8: Dirty blade

In many cases, the emerging blade problem stems simply from inadequate cleaning of the blade holder or is due to an incorrect or inconsistent blade angle. In Fig. 8 and Fig. 9, two examples can be seen of the condition of blades, as often found in paper machines. The dirt on the blade around the blade holder can be both inorganic (filler, dust) and organic (fibre residues, bio films). In combination with the prevailing moisture and elevated temperature, it can lead to very resistant impurities. When changing the blade this dirt can slip into the blade holder and result in significantly raised or lowered contact pressure. In addition, it can happen that the dirty blade holder is no longer able to create the same contact pressure at the tip of the blade when the same hydraulic pressure is applied, because the mechanics are heavily soiled.

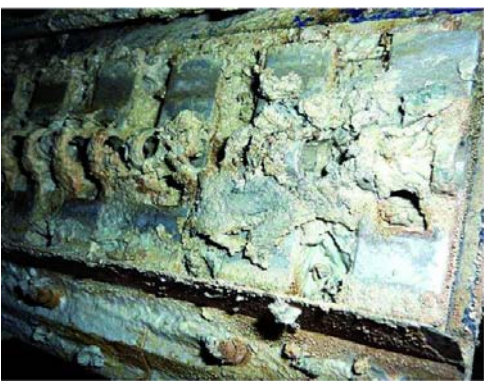
Fig. 9: Dirt on the blade, in detail

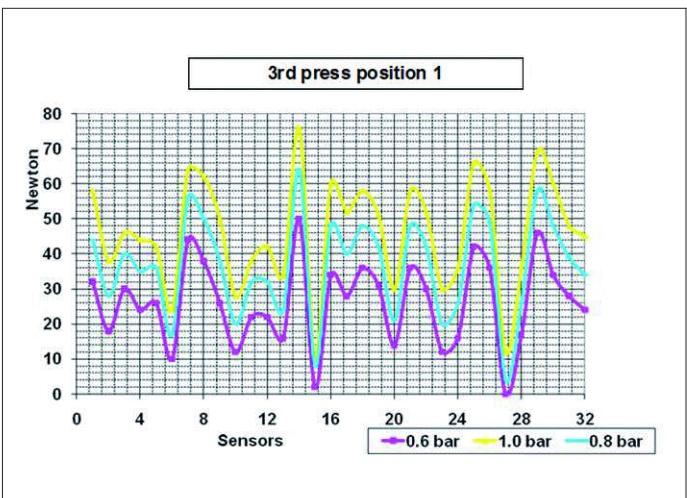
Fig. 10: Contact-pressure curves in the third press with different contact force [N]

Measuring the contact-pressure profile in the cross direction generally takes place at the normal production pressure level of the respective blade and at higher and lower contact pressure. A typical measurement curve; for a third press, can be seen in Fig. 10.

It is easy to recognise that, in this case, sufficient contact pressure to avoid “packers” is not obtained in some places (Sensors no. 6, 15, 27) when a pressure of 1.0 bar is applied, even though this is 20 % higher than the usual pressure of 0.8 bar. This presents a serious hazard potential and the blade holder should be cleaned before other measures are taken. If the problem remains, changing the blade holder may be necessary. If individual press fingers were broken, repairs may be a possible solution. A similar curve for a drying cylinder is shown in Fig. 11. Here, the usual pressure was at 2.5 bar, and it is easy to recognise that this gives good results.

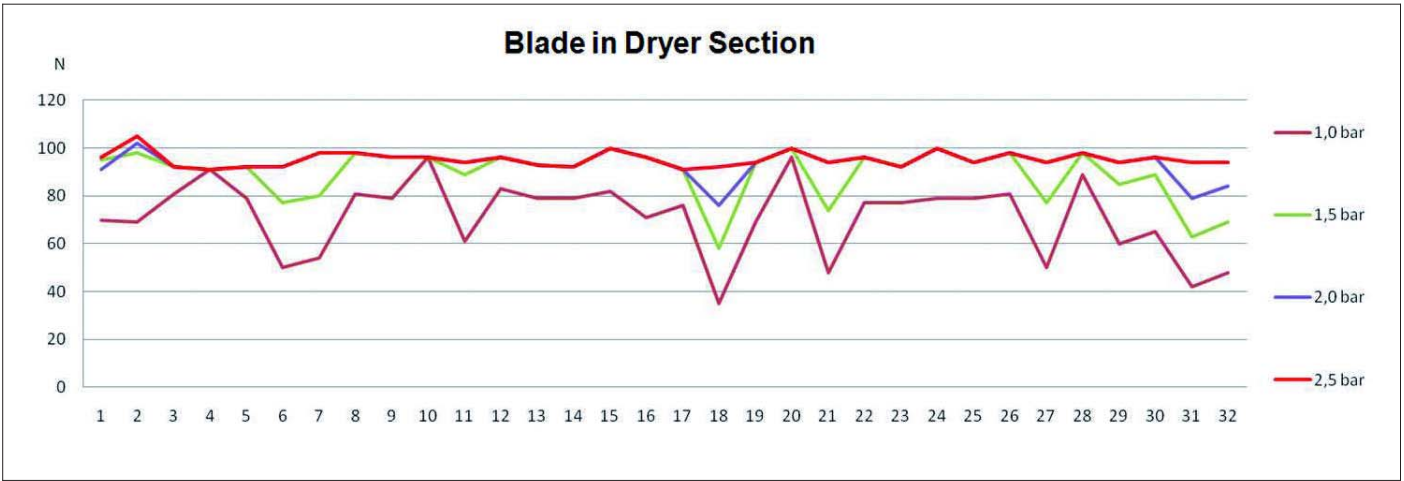
Fig. 11: Contact-pressure curves in the third press, with different contact forces [N]

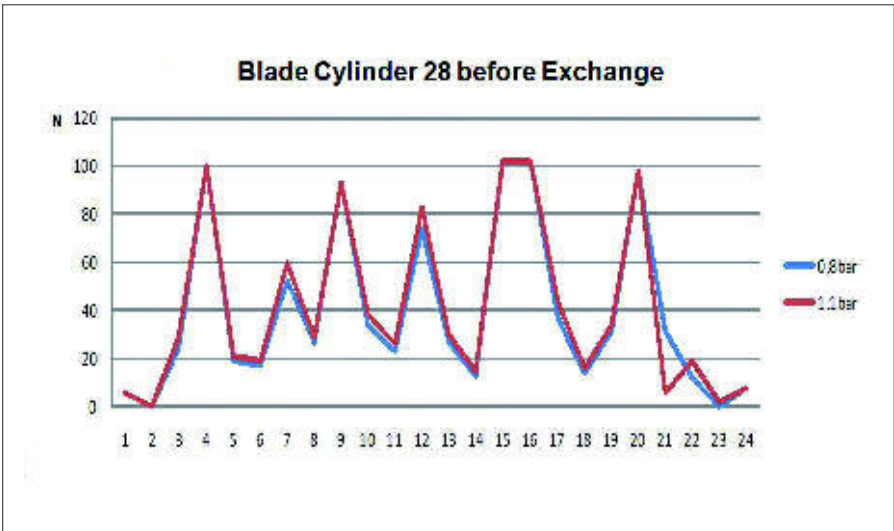
Fig. 12: Contact-pressure curves in the third press, with different contact forces [N]

A reduction in contact pressure below 2.0 bar is not advisable in this case. A similar curve with a bad blade in a dryer section, as shown in Fig. 12 below, illustrates how a change of air pressure / contact pressure does not lead to a change of the real contact pressure at the tip of the blade. There are also massive fluctuations in the contact-pressure cross-direction profile, which suggests that urgent measures need to be taken. An example of a catastrophic cross-directional contact-pressure profile can be seen in Fig. 13. At the edges of the roll, virtually no pressure is applied to the tip of the blade – which inevitably results in problems with deposits and runability.

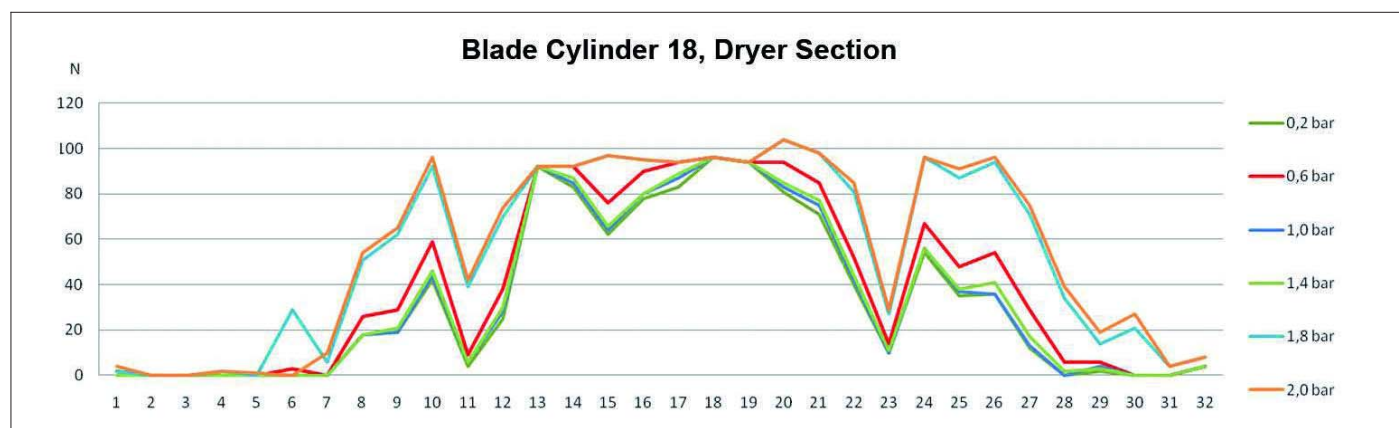
Fig. 13: Very poor contact-pressure profile

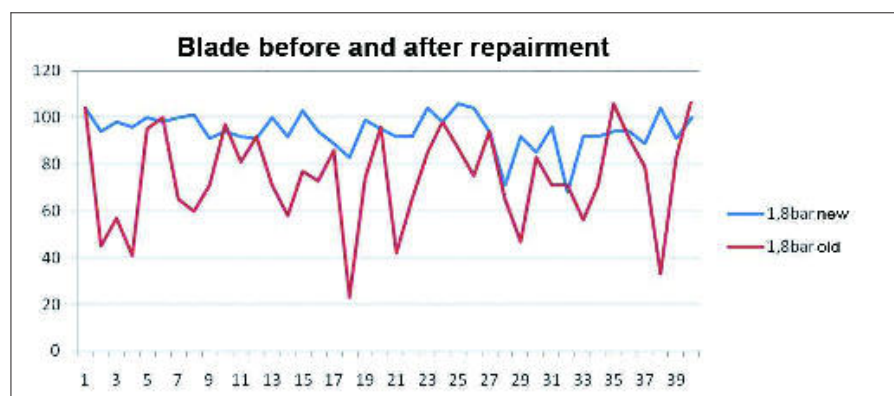
Fig. 14: Contact-pressure profile before (red) and after repairs (blue)

That measures to optimize blade systems are worthwhile and possible is illustrated in Fig. 14, which shows the contact-pressure profile of a blade on a central roll before repairs (red), and after repairs. After repairs the profile still has minor weaknesses in the area of sensors 28 and 32, but is clearly better than before repairs, and is good enough for normal operation of the paper machine.

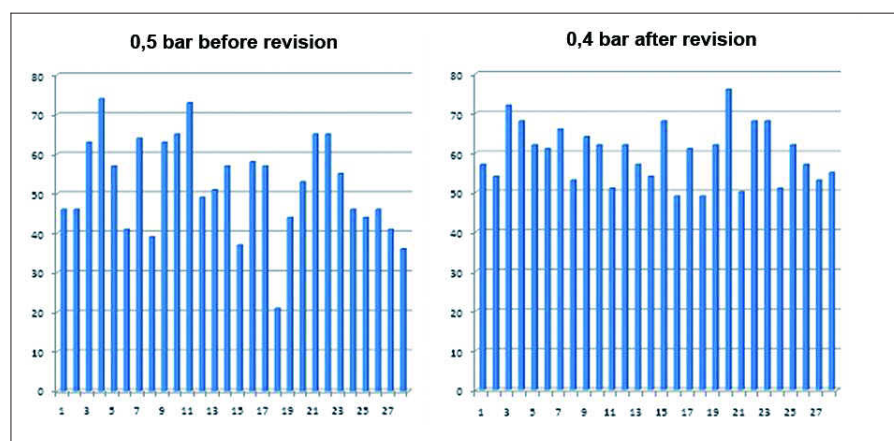
Fig. 15: Contact pressure-profile before (left) and after correction (right)

An analogue improvement is given in Fig. 15. It is clearly shown that the contact pressure profile has been significantly improved by the repairs. Whether the problems result from the lowering mechanism of the blade holder can be determined by inspecting the total contact pressure at higher and lower air pressures. In Fig. 16, the pressure measurements for an irregularly-functioning blade holder are illustrated and, in Fig. 17, those for a problem-free functioning blade holder.

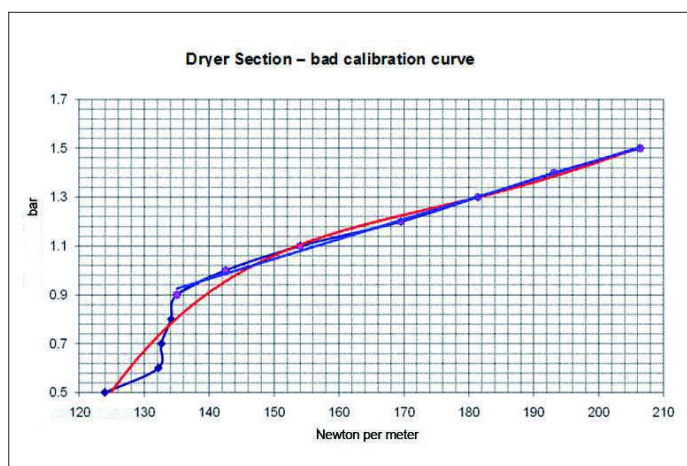
Fig. 16: Contact pressure diagram of an irregularly-functioning blade holder

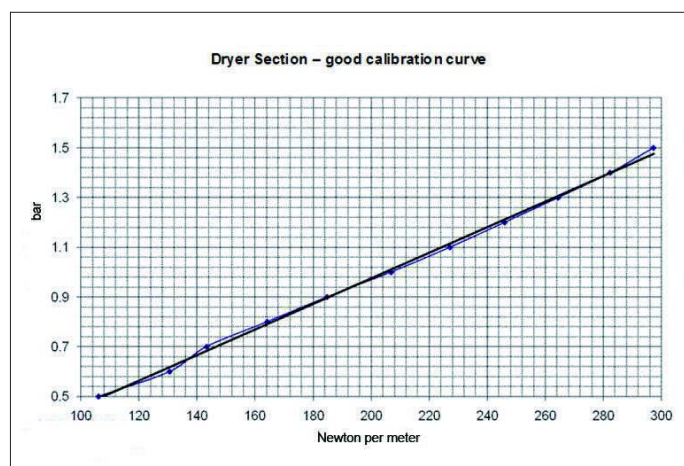
Fig. 17: Contact pressure history of a functioning blade holder
